# ViskoTeepak Complaint Approach

ARTICLE 1

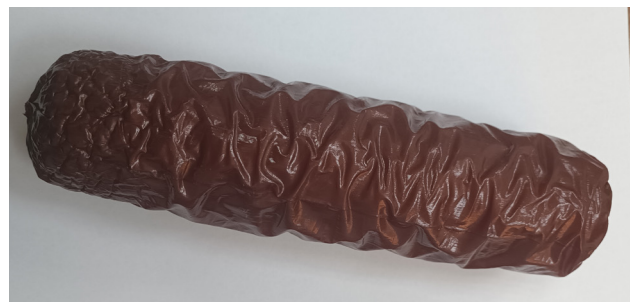
### Issue 1 – Adhesion Issues

Customer 1 has been using Fibrous 055 HP-H for many years without any issues. All of a sudden there were problems with the adhesion. The casing lifted off and did not follow the shrinkage of the sausage. Initially the customer's reaction was to blame the casing.

As it seems now the customer bought 25 kg blocks of fat with inconsistent quality. The percentage of soft fat within the blocks combined with a low melting temperature was out of specs resulting in a fat film created between the casing and the sausage surface during the start of heating. This prevented the casing from sticking to the sausage surface.

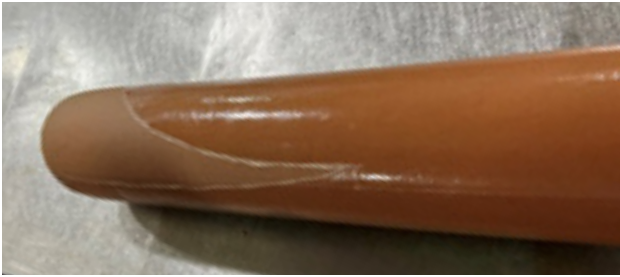
### **Issue 2 – Adhesion/Peeling Issue**

The approved product was commercialized 6 months later in a different season of the year. The first sausages out of this commercial production showed too much adhesion and the casing was hard to peel off.

Our tech team found out that the local weather during the trials was completely different from the commercial run conditions. Different temperature and humidity changed the product properties, i.e. evaporation, shrinkage, humidity, and the final caliber. This had a negative effect on the adhesion level with the existing casing. Therefore we strongly recommend to include an upscale trial before starting with the commercial volumes.

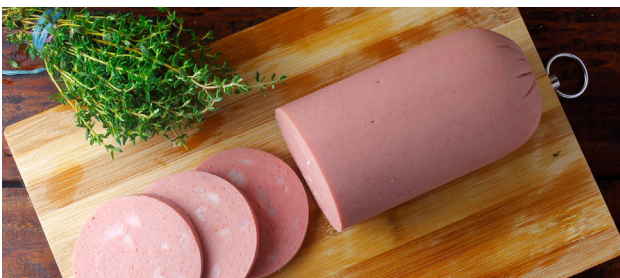
### **Issue 3 – Peeling Issue**

the casing could not be peeled off anymore. After studying the local circumstances, it seemed that a temporary operator did not follow the requested stuffing diameter. The casing was filled to the max, just under the burst pressure. The meat emulsion was pushed hard into the casing. Therefore, the inside easy peel layer did not have the possibility to do its job.

After correcting the procedure, the process ran without any issue.
