Fibrous

ViskoTeepak Complaint Approach - Article 2

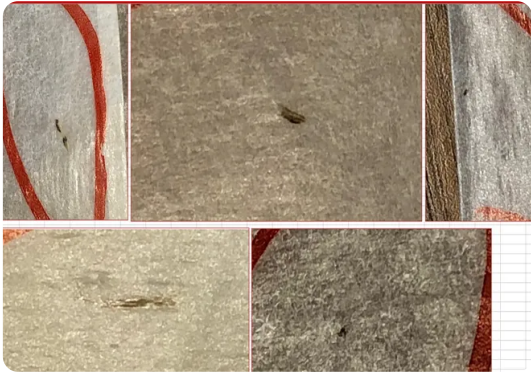
Issue 4 - Unidentified Elements in the Casing

Sometimes the customer happens to notice “black spots” embedded in the casing. Unidentified elements for our customers as shown in the pictures. Customers will usually refer to such unidentified elements as a piece of metal, a hair, or ink.

However, by far, most of the time the analyses show that these spots are actually pieces of wood, i.e. the raw material for cellulose. Harmless in nature, but it looks suspicious.

The basic material we use in our fibrous casing production is the wood that comes from the abaca plant. The wood is chemically treated to obtain liquid cellulose that will be eventually converted into a wide roll of paper. The liquid cellulose is pre-filtered to make it homogeneous and remove any bigger elements. Sometimes, however, very small pieces of wood do slip through the system and show up in the paper used at a later stage to manufacture our fibrous casing.

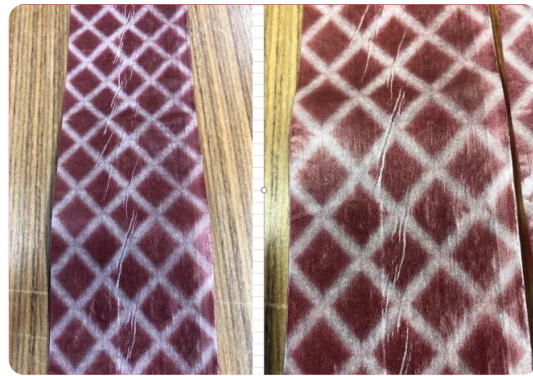
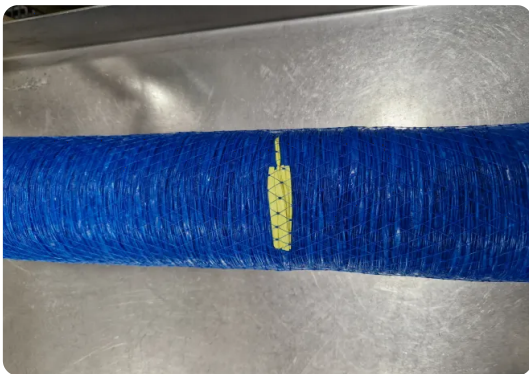
Issue 5 – Pleats on the reel stock resulting in poor printing

At the end of the fibrous extrusion process, the casing is reeled up. This is a very accurate job where tension, direction and workmanship are very important. During reeling, some pleats or folds may show up due to various causes. Most of the fibrous casing at the end of the processing, some folds show up. Most often it's related to incidents detected immediately by the system. Once detected, folded casing is taken out of the process.

Sometimes few folded meters do slip through the manual control. As such reel stock only affects the printed casing.

A second check is implemented during printing, and improperly printed product will show up in the market only in a very limited number of cases.
